Technical Note

title: REPAIR SYSTEM FOR DAMAGED COATINGS ON NAVY
ANTENNA TOWERS — PART I

author: L. K. Schwab and R. W. Drisko

date: March 1978

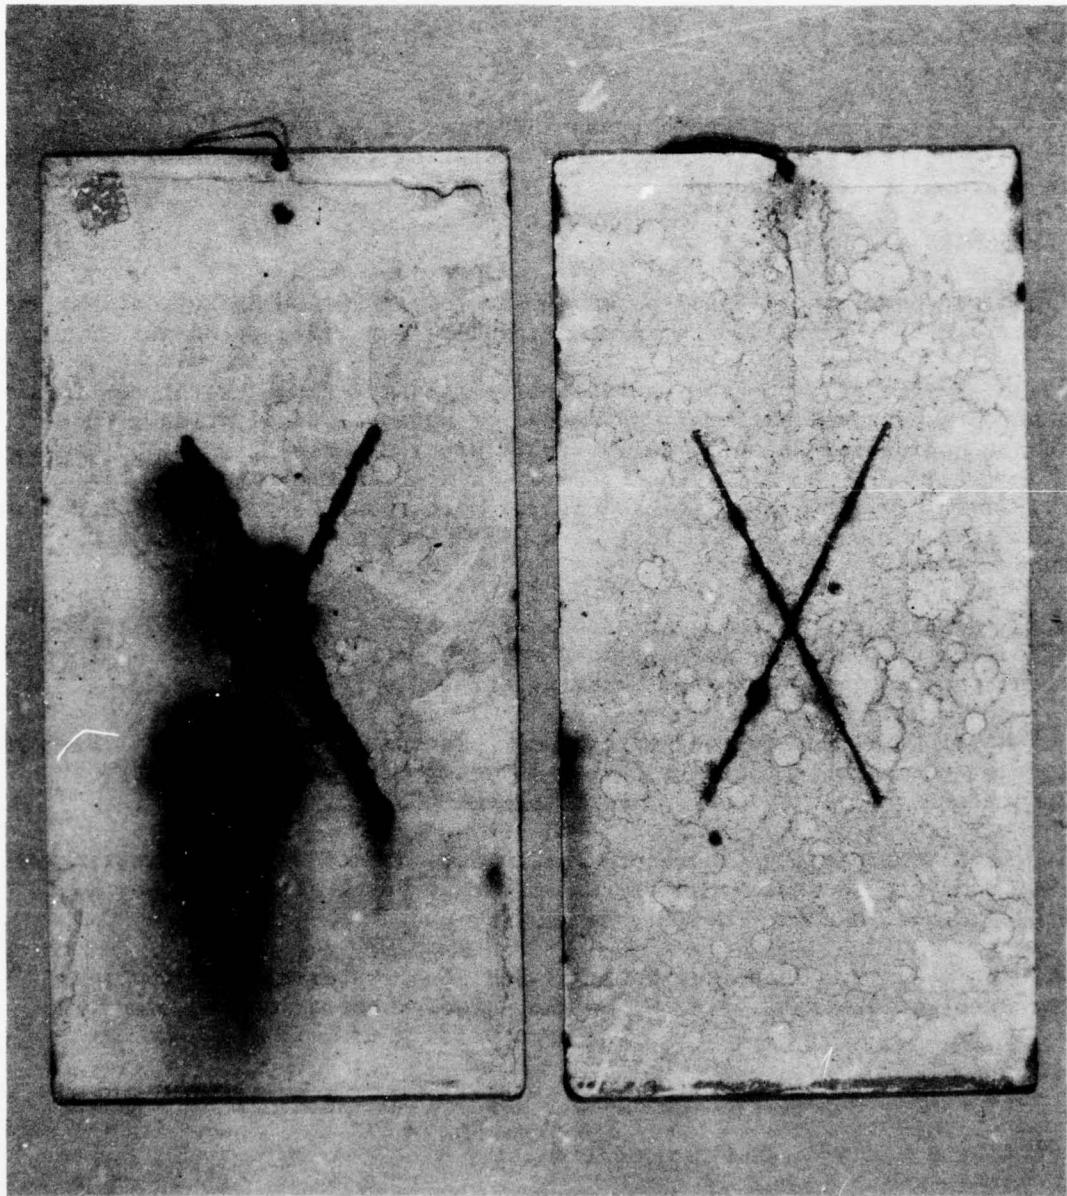
Figure 1. Weathered paint panels (left to right, Systems II and I).
